GEOPHYSICAL SUBSOIL CHARACTERIZATION OF A HOUSING UNIT SHAKEN BY THE EARTHQUAKE OF SEPTEMBER 19, 2017 (MW 7.1)

Geophysical Department - School of Engineering, UNAM

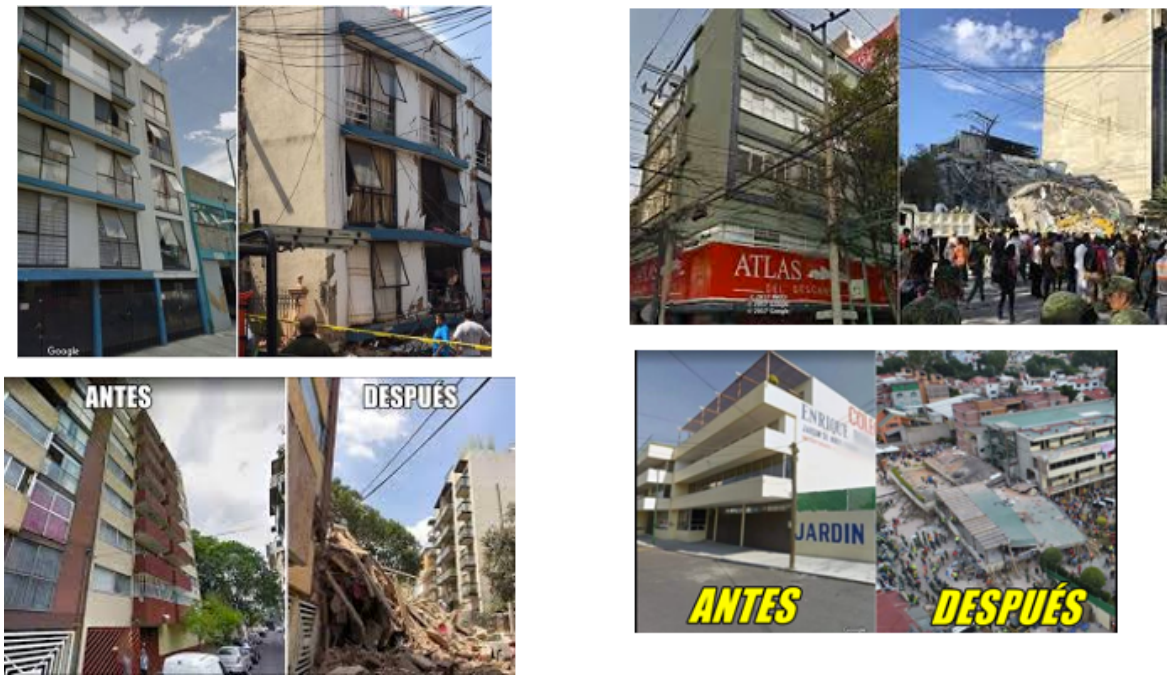
It was a near epicenter (150 Km) that produced spectral accelerations at low periods (0.2-1.5 s). Most of the affected buildings had 3 to 7 levels.

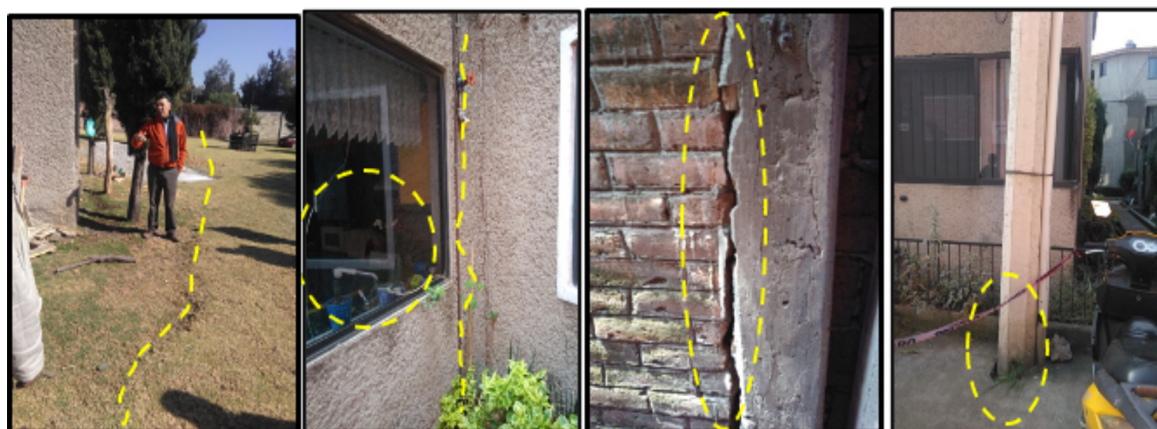
The damages observed were sinking, Soil deformation, cracking, cobblestone damage, broken windows, and fracture of walls

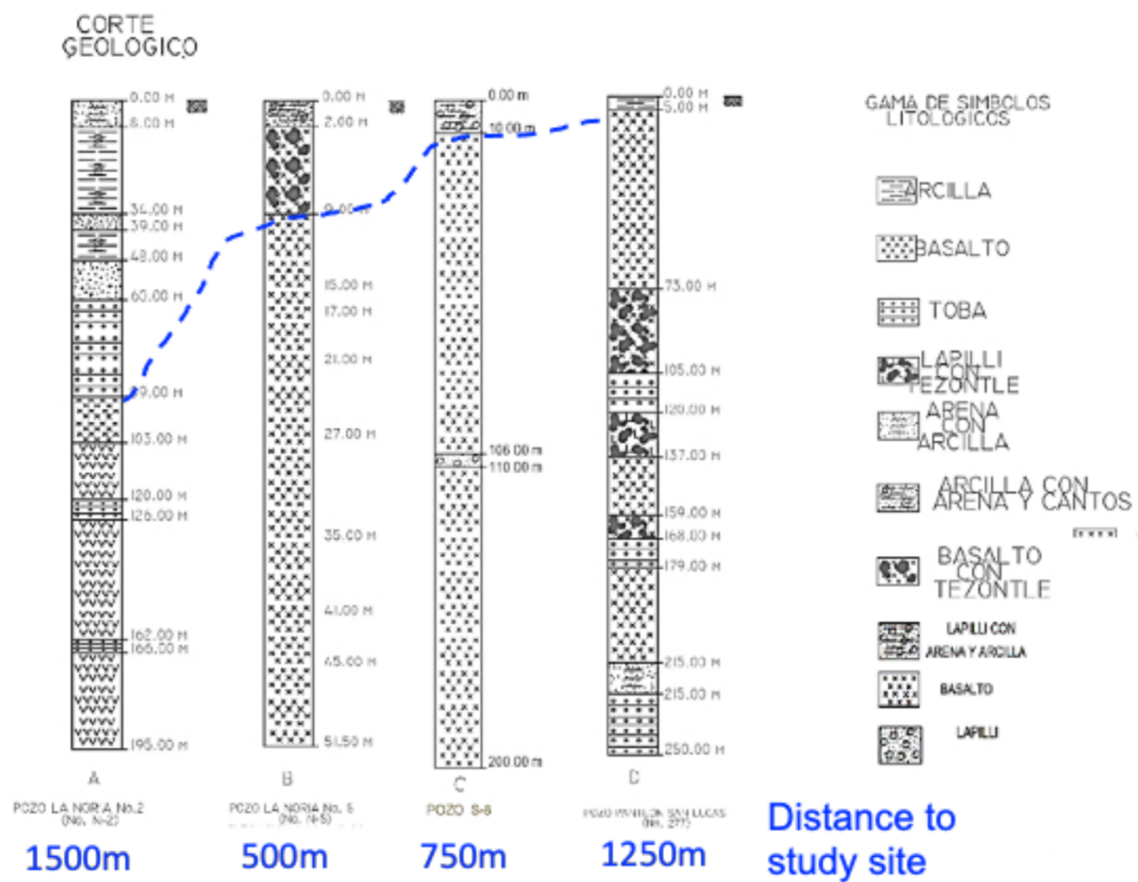
The lithology is conformed of lake clays, clays with sands and boulders, basalts with tezontle, stuffs, and lapilli. In general, there is a significant irregularity in the distribution of subsurface materials over short distances. The figure shows the depth at which basalt can be found in the study area.

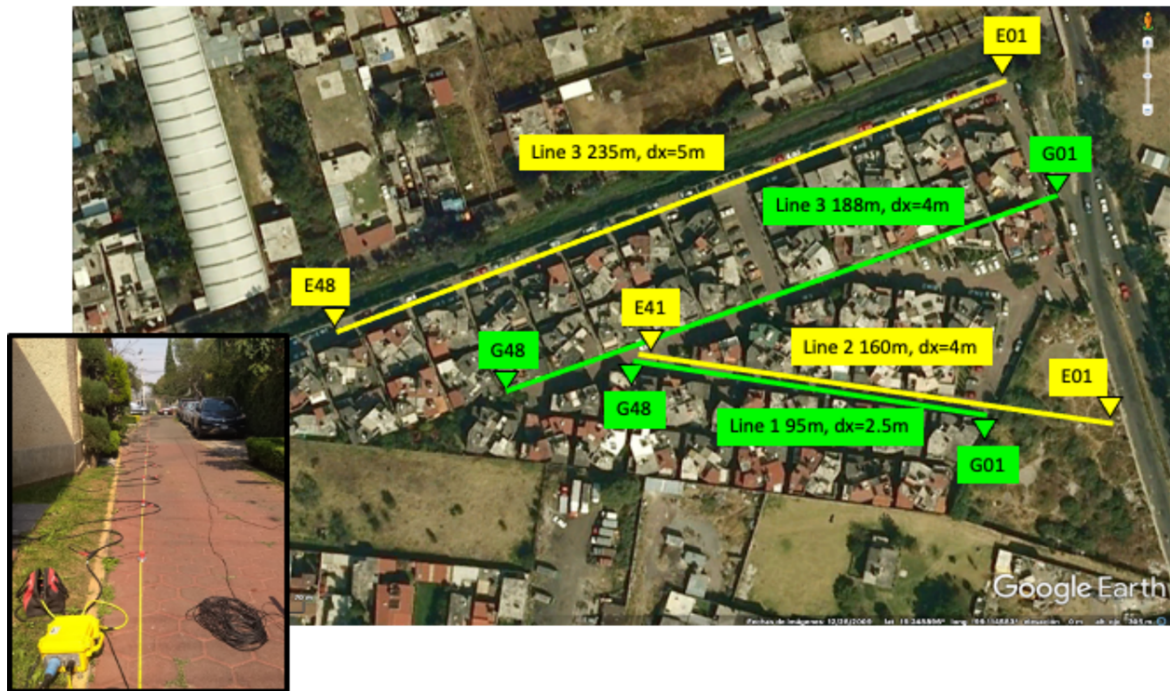
ERT

Resistivimeter
Iris Syscal pro with 48 channels
495 Quadripoles
Wenner-Schlumberger Method

SNI

2 Geode seismometers
48 channels
Vertical geophones
60 min of seismic noise
Several H/V measures

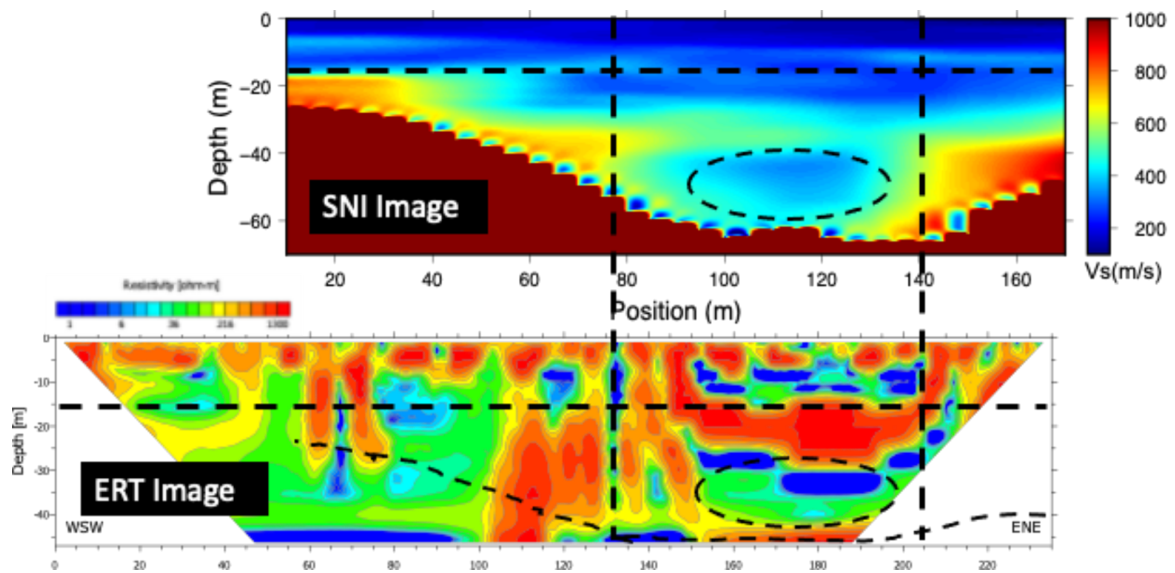
ERT vs SNI results

We compare the images obtained by the two methods. SNI can not resolve in the first 20 m depth, where ERT shows resistive materials. SNI exhibits an irregular substratum, while ERT indicates a vertical discontinuity to the middle of the profile. A remarkable similarity of the vertical distribution of properties is observed at the center of both studies.

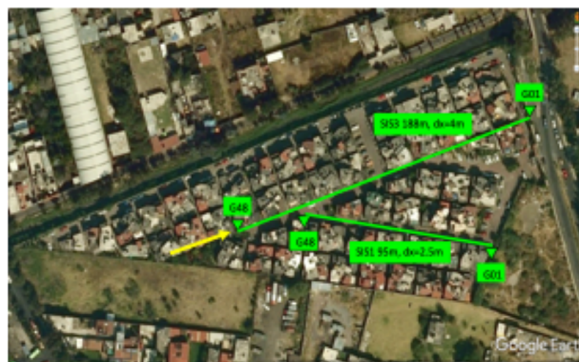
Cross-correlations, Line 3. Source virtual sections

We carry out seismic noise-correlations between all pairs of receivers. The wave trains emerge with amplitude remarkable in time delays less than 2 s. The pulses have a high signal to noise ratio and emerge consistently either in the anti-causal or causal side.

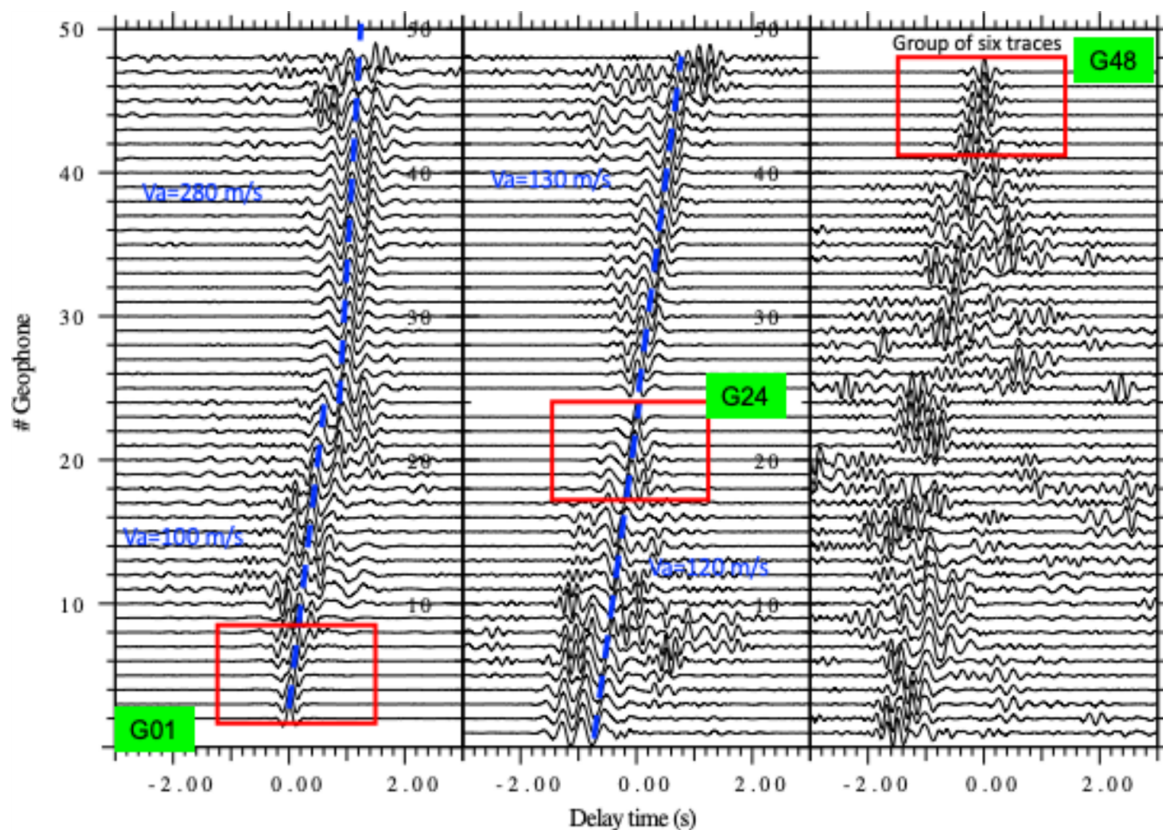
We observe sudden changes in velocity, and the correlation is lost in some receivers. After the virtual source position, the continuity of the correlation pulse can be followed in the first six receivers.

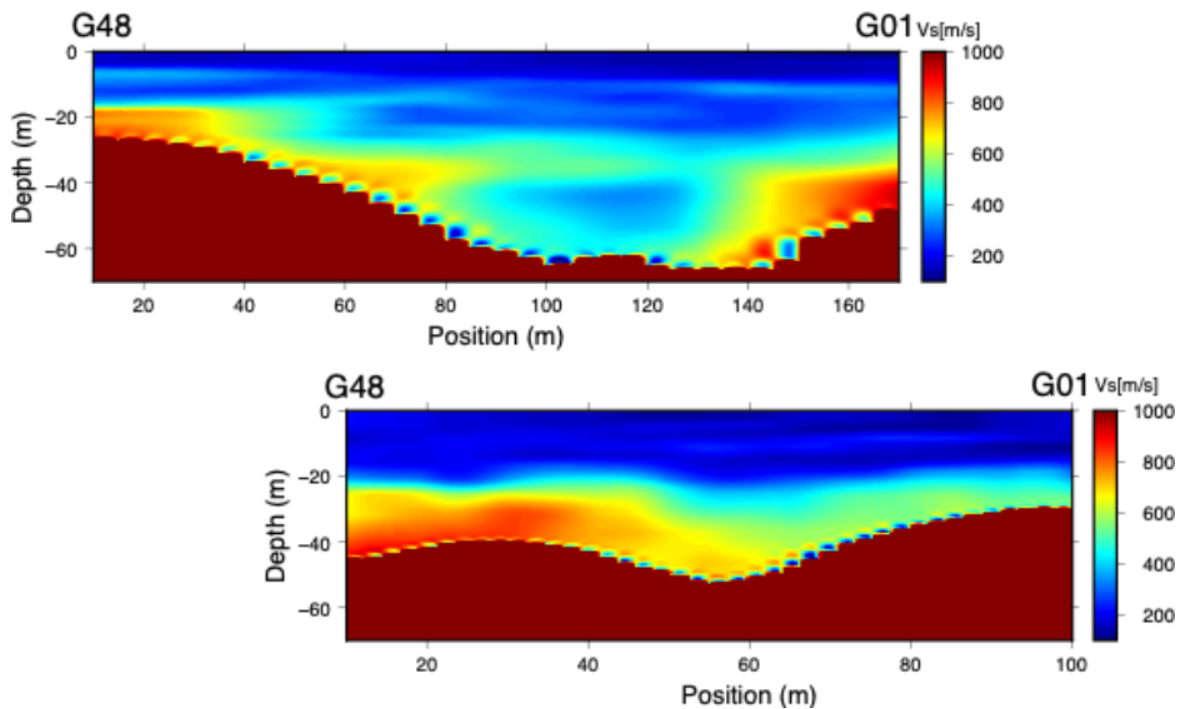
2D Vs sections were built from the interpolation of the 1D Vs profiles. In the first 20 m depth, the dispersion curves do not define the structure; they only indicate a layer with average velocities at 150 m/s. The CMPCC analysis allows defining the Vs lateral variation.

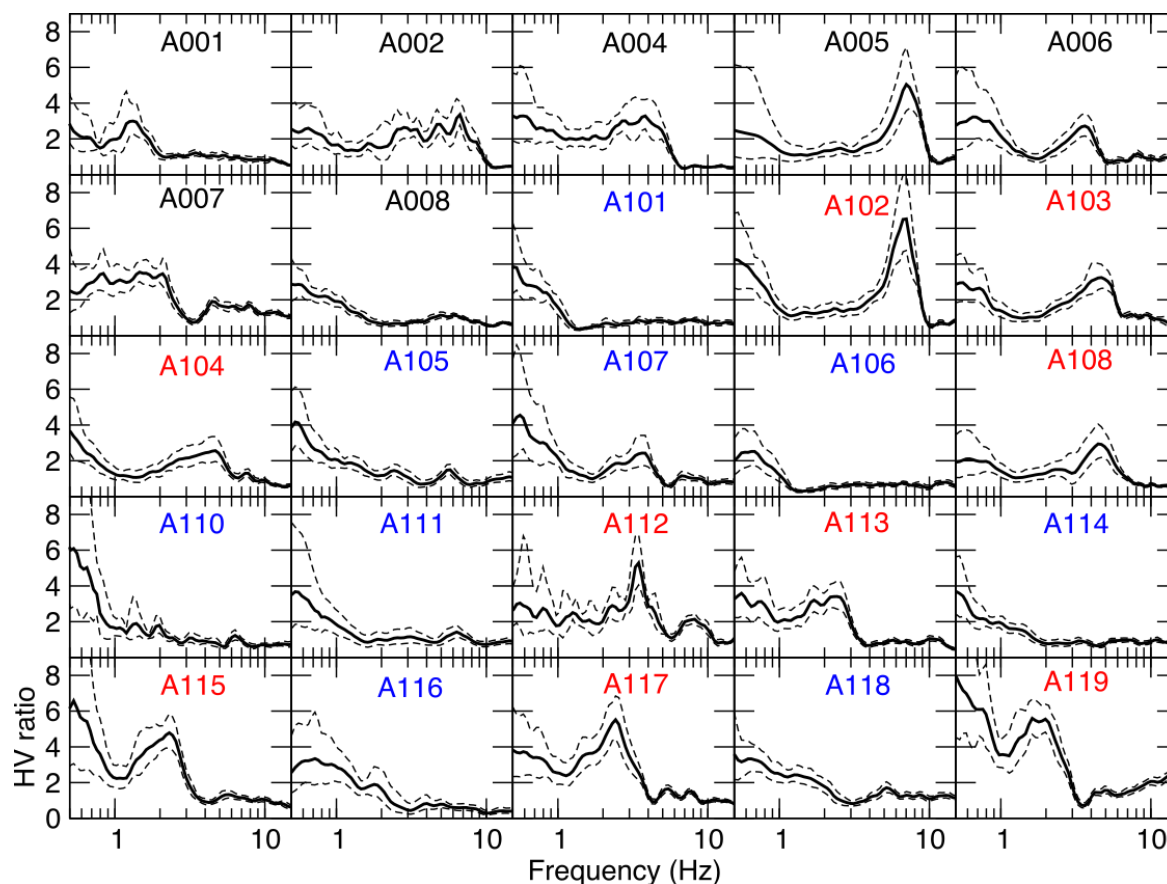
H/V spectral ratios

We explored the possible presence of soft materials and the substratum depth using 25 measurements of 30 min of seismic noise to apply the HVSR method. We observe weak impedance contrast, but it was enough to indicate the seismic response of a soil layer in the frequency range of 2 and 7 Hz.

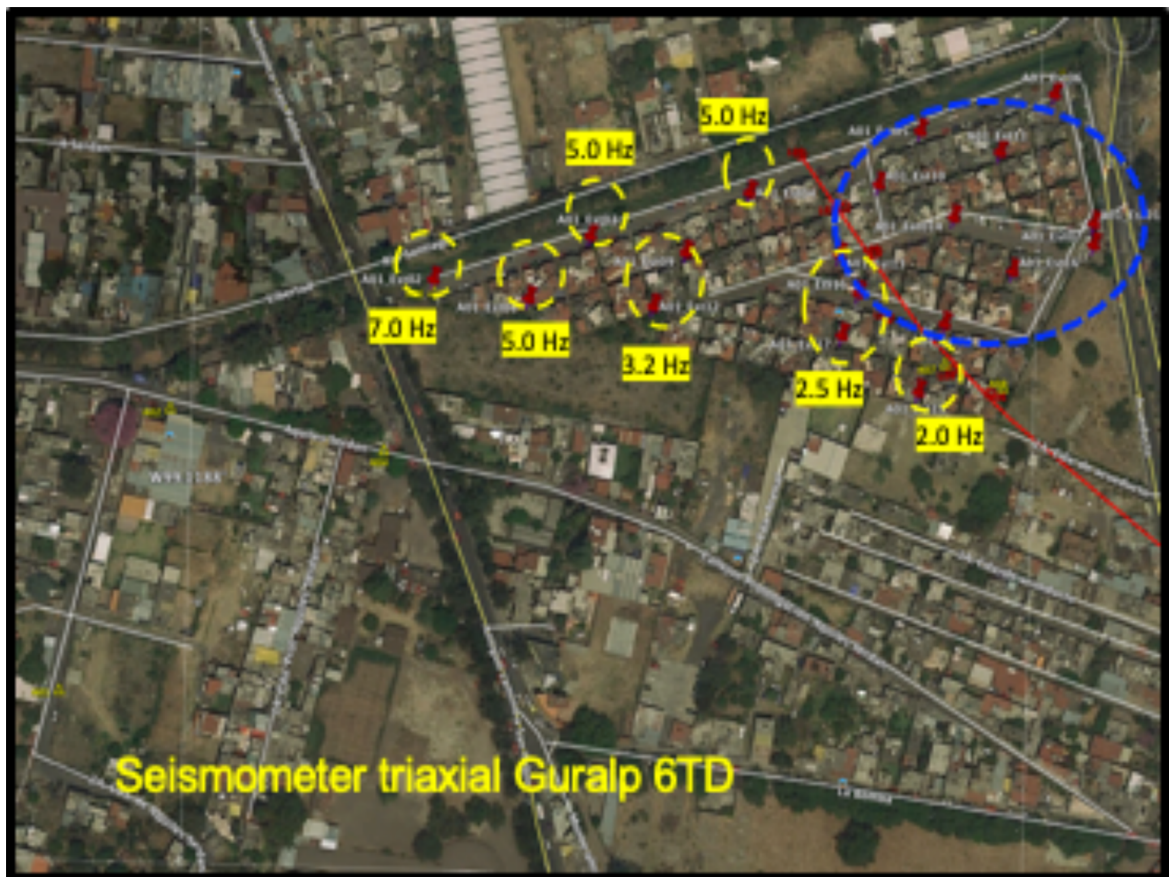
The soil frequencies are only present on the West side of the study area (yellow circles). Whereas on the East Side, the spectral ratios are flat (stations inside a blue circle).

The absence of soil frequencies in the east part may be due to resistive materials close to the surface, which cannot be detected by the dispersion curves.

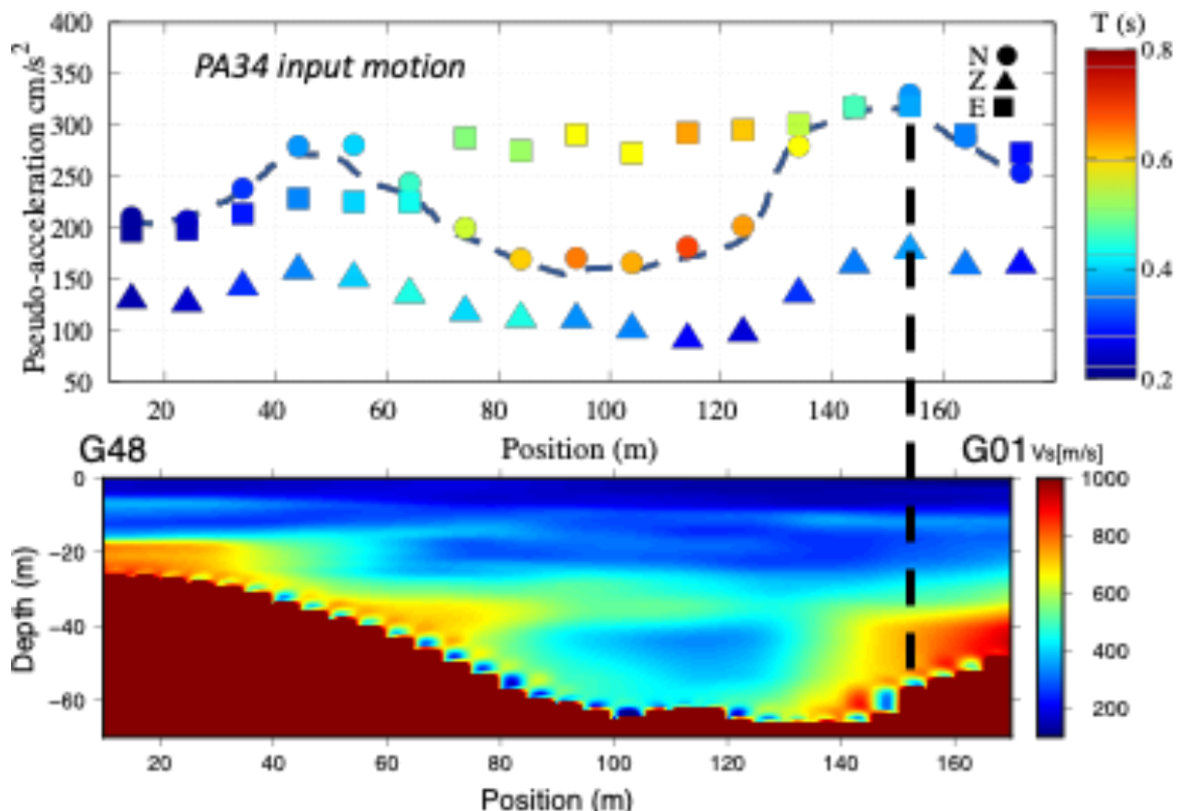
The response spectra of two close accelerometric stations (PA34 and CUP5) show maximum accelerations near 4 Hz (using the 1D VS model indicated by the vertical dashed line).

A strong effect of soil amplification due to the lateral Vs irregularity, and shallow bedrock, is observed (blue dashed line). In the center of the model, the site periods are increased according to the soft materials' depth.
