Avoidance and Early Diagnosis of Erroneous Permanent Pacemaker Placement into the Left Ventricle: A Case Report

Abstract

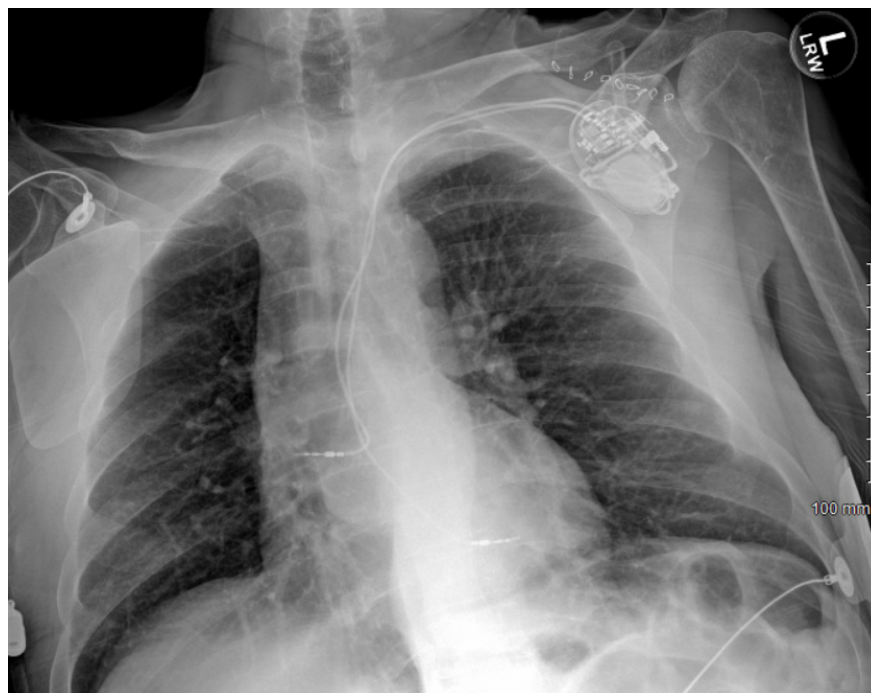
Figure 1 . Anteroposterior view of the chest showing no evidence of pneumothorax with the atrial lead in good position while the ventricular lead is higher. This can suggest inadvertent lead placement but lateral chest x-ray is needed for further evaluation.

During implantation of a permanent pacemaker, the right atrial lead was appropriately placed via the left subclavian vein into the right atrial appendage. However, the ventricular lead was placed via the subclavian artery into the left ventricular cavity. He was admitted to the hospital overnight and a chest x-ray was

obtained the next day, showing no evidence of pneumothorax (**Figure 1**). Surprisingly, his ECG showed atrial pacing with long AV delay and intermittent ventricular pacing with the paced ventricular beats showing right bundle branch block morphology contrary to the expected left bundle branch block morphology seen when the lead is inside the right ventricular cavity (**Figure 2**). A limited bedside Echo was obtained that showed the ventricular lead clearly crossing the aortic valve to the left ventricular cavity and fixed into the inferolateral wall of the left ventricle (**Figure 3**). Early recognition of this serious pacemaker implantation complication led to pacemaker revision in the same day with extraction of the arterial lead and reinsertion of the ventricular lead via the left subclavian vein into the right ventricular cavity (**Figure 4**). The pacemaker revision went uncomplicated.

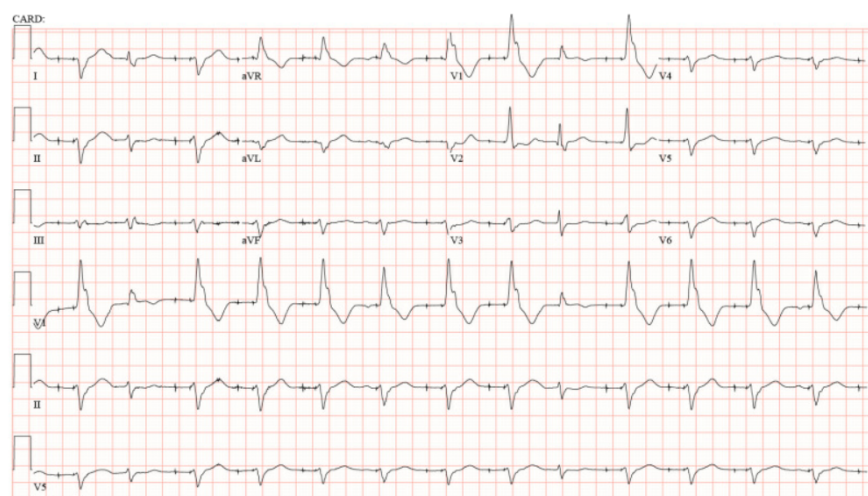
Figure 2. A 12-lead ECG showing atrial pacing with long AV delay (blue circle) and intermittent ventricular pacing (red circle). The key point is that the ventricular paced beats are conducted with right bundle branch block morphology suggesting that the ventricular lead is located in the left ventricle.

There are several methods available to avoid the occurrence of such events. When subclavian vein puncture is attempted, the subclavian artery may also be punctured. Arteriography may be used to identify the accessed vessel. In addition, successful venipuncture may be observed as the guidewire advances into the inferior vena cava under fluoroscopy. If there are ventricular premature beats with right bundle branch block pattern soon after the guidewire enters the ventricular cavity, the possibility of the guidewire entering through the artery must be considered. After the pacemaker is implanted, correct positioning of the pacemaker may also be seen through ECG. Right ventricular pacing is indicated when ECG shows left bundle branch block appearance, while left ventricular pacing is seen in right bundle branch block patterns (5).

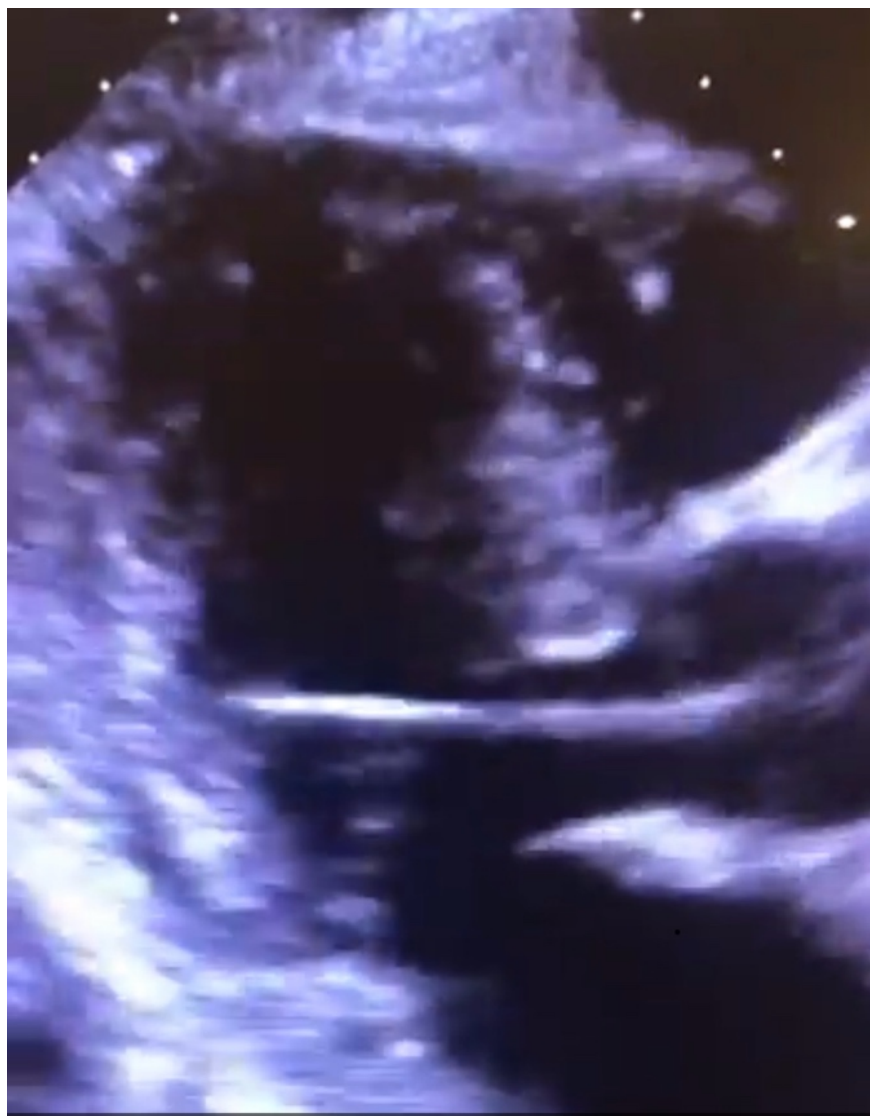
Figure 3 . Parasternal long axis view showing pacemaker lead (arrow) crossing the aortic valve into the left ventricular cavity and fixed to the inferolateral wall of the left ventricle.

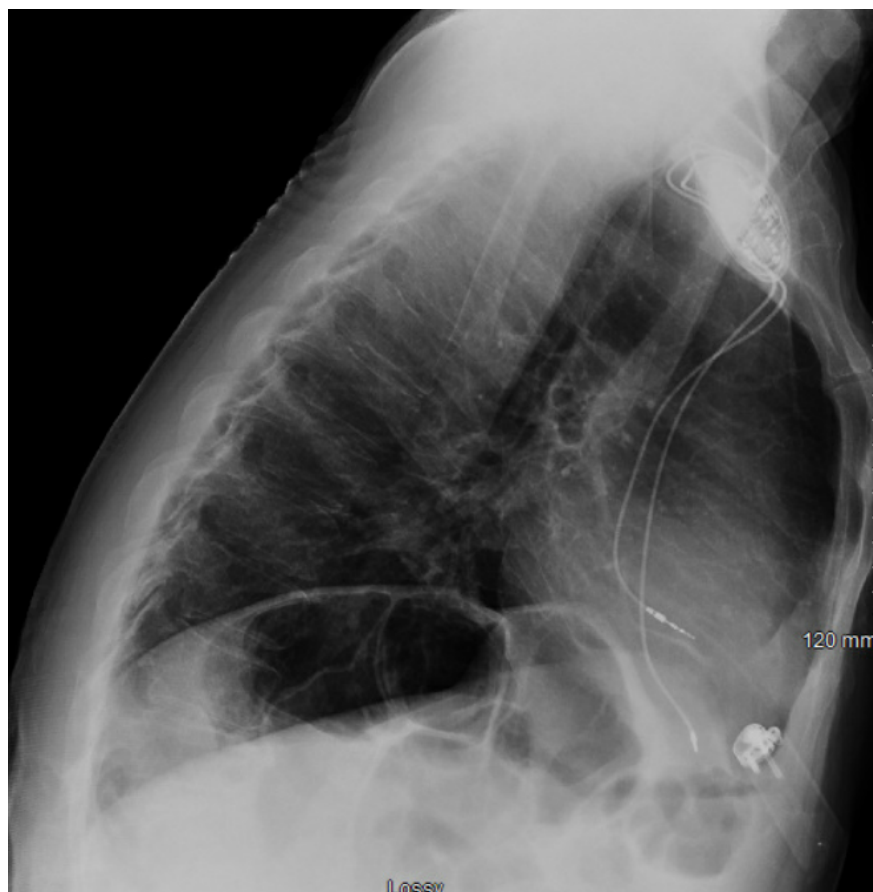
Figure 4 . Lateral chest x-ray view post-pacemaker revision with the ventricular lead directed anteriorly suggesting right ventricular position.
