OPTIMIZATION OF ESTHETIC REHABILITATION IN TOOTH WITH ENDODONTIC IMPAIRMENT

There is need to optimize dental procedures for better productivity and patient acceptance, without, however, reducing the quality of the results obtained. The objective of this work is to present a clinical case that illustrates endodontic retreatment followed by installation of a fiber glass post and coronary preparation.

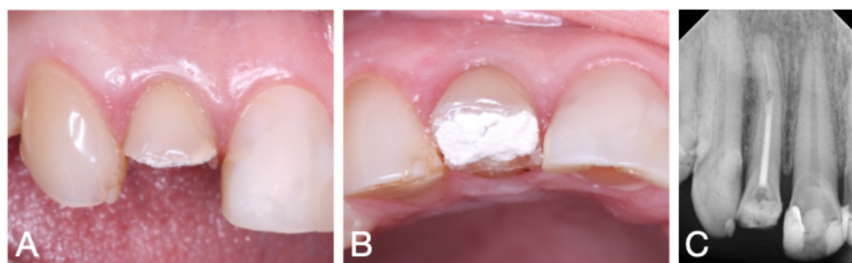
Figura 1. (A and B) Intraoral photos showing the initial appearance of tooth 12; (C) periapical radiograph showing unsatisfactory endodontic treatment of tooth 12.

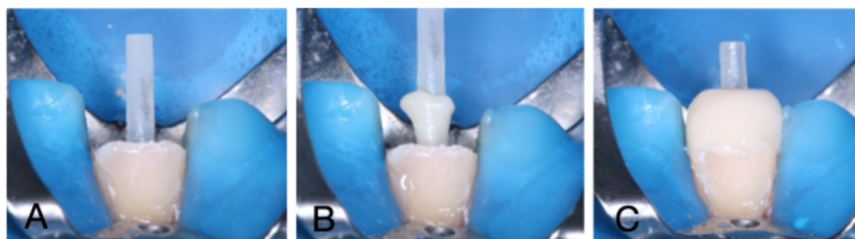
Figura 2. Post test in the root canal; (B) Reanatomization of the post with composite resin; (C) composite resin filling core after post cementation.

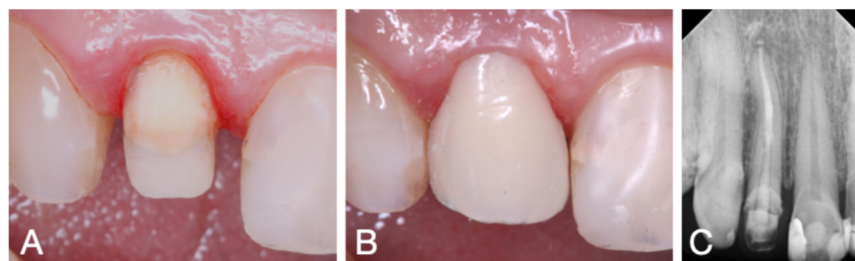
Figura 3. Aspect of the initial supragingival preparation; (B) provisional restoration; (C) radiographic appearance after endodontic retreatment shows adequate apical sealing.

and rubber kit (Professor Marcelo Hayashida Kit – Dhpro, Paranaguá, PR, Paraná) and it was cemented with temporary cement (Temp-bond NE – Kerr, Scafati, Salerno, Italy) (Figure 3 – B). Through periapical radiography it was possible to observe that the endodontic treatment was satisfactory with adequate apical sealing (Figure 3 – C). The second session proceeded with the refinement of the preparation and impressions. It began with the removal of the temporary restoration and gingival retraction to complete the preparation at the subgingival level (Figure 4 – A and B). The thinnest cord selected #000 (Ultrapack – Ultradent) impregnated in hemostatic solution (Viscostat - Ultradent) was inserted into the gingival sulcus followed by the second retractor cord #00 (Ultrapack – Ultradent) and subgingival extension of the preparation was performed using diamond tip #4138 (KG Sorensen) (Figure 4 – C). The finishing of the corners and edges was carried out with medium and fine grain sandpaper discs (Soflex pop-on – 3M Espe, St. Paul, MN, USA) and diamond tip #4138 F (KG Sorensen) (Figure 4 – D). After completion of the preparation, the impression was taken using the two-step technique. The molding material used was addition silicone (President – Coltene, Altstätten, Switzerland) (Figure 5). After selecting the tray, the first molding was carried out with the heavy material, performing tilting movements in order to create space for the light material. After its setting and removal from the tray, the most superficial retractor wire was removed and the tray was loaded with the light silicone and placed in position in the mouth. Finally, the tray was removed from the mouth and the impression was washed under running water and sent to the laboratory for the fabrication of vitreous ceramic restorations based on lithium disilicate (IPS e.max, Ivoclar Vivadent, Schaan, Liechtenstein). Color selection was made using specific scale. The provisional restoration was relined with self-curing acrylic resin (JET – Classic); the finishing and polishing was done using a milling and rubber kit (Professor Marcelo Hayashida Kit – Dhpro) and it was cemented with temporary cement (Temp-bond NE – Kerr). In the third session, with the ceramic piece in hand (Figure 6 A and B), the provisional was removed, the preparation was cleaned using a Robson brush (Figure 6 C), and the crown was tested in the mouth to verify esthetics and adaptation. For cementation, absolute isolation of the operative field was performed. The enamel area of the preparation was etched with 37% phosphoric acid (Condac 37 – FGM) for 30 seconds, washed for 30 seconds and dried with an air jet. Then, the self-etching adhesive system (Clearfil SE Bond – Kurakay) was applied following the manufacturer's instructions followed by light curing for 10 seconds on each face. The internal conditioning of the piece was performed with 10% hydrofluoric acid (Biodynamics - Ibipora, PR, Brazil) for 20 seconds, followed by washing and drying (Figure 7 A). It was then conditioned with 37% phosphoric acid (Condac 37 – FGM) for 15 seconds, followed by washing and drying for application of Silane (Prosil - FGM) (Figure 7 - B and C). Finally, the dual resin cement (Allcem Core - FGM) was applied inside the ceramic crown and finally, the piece was placed in the preparation (Figure 8 A). Excess cement was removed from the margins using a spatula and brush. Then, light curing was carried out for 40 seconds on each face (vestibular, incisal and palate). Subsequently, the occlusal adjustment was performed using Accufilm carbon paper (Parkell - Farmingdale, NY, USA). The esthetic and functional result obtained was satisfactory and satisfied the patient's complaint (Figure 8 - B and C).

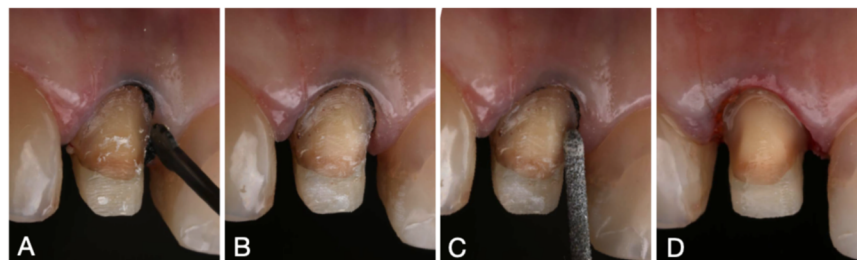
Figura 4. (A and B) Gingival retraction with retractor wire; (C) Subgingival extension of the 4138 diamond tip preparation; (D) final aspect of the preparation.

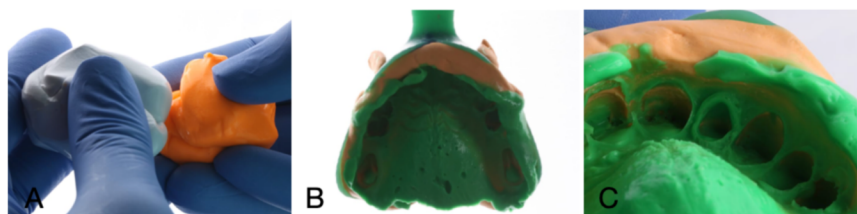
Figura 5. (A) Mix of heavy silicone addition material; (B and C) aspect of the mold.

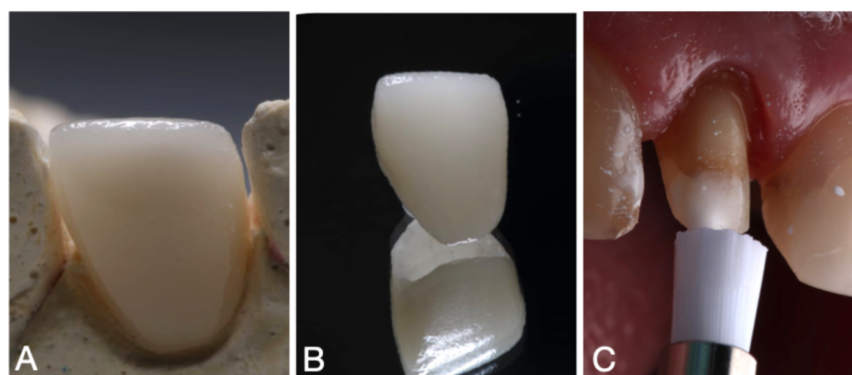
Figura 6. (A and B) Lithium disilicate ceramic crown; (C) cleaning the preparation with a Robson brush.

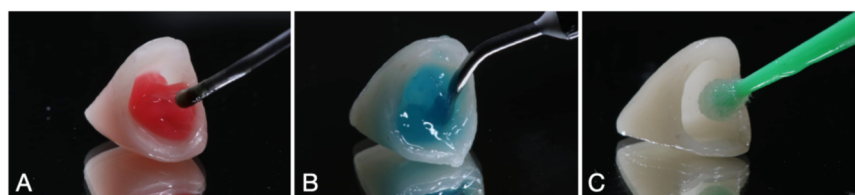
Figura 7. (A) Internal conditioning of the crown with 10% hydrofluoric acid; (B) internal cleaning with 37% phosphoric acid; (C) silane application.

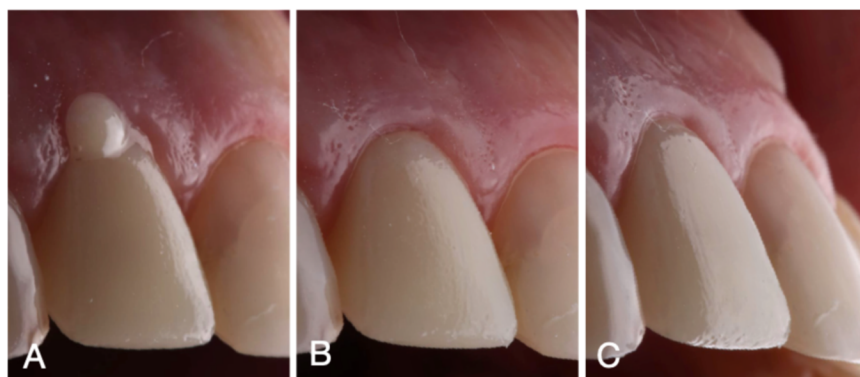
Figura 8. (A) Cementation of lithium disilicate crown with resin cement; (B and C) final appearance after cementation.
