Safety Assessment of Coronary Arteries During Left Bundle Branch Area Pacing

Qiling Kong¹, Huolong Chen², Juan Hua¹, Ziyi Xiong¹, Shuyun Le¹, Jinwei Liu¹, and Qi Chen¹

¹Nanchang University Second Affiliated Hospital

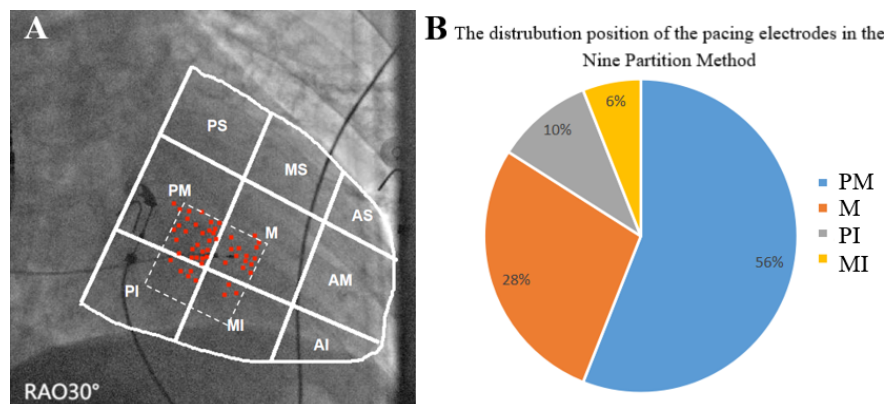
Figure 3 (A) At RAO 30°, the red dots represent the two-dimensional distribution of the tips of the LBBAP electrodes, and the white dotted rectangle is composed of the central points of the PM, M, PI and MI positions. (B) Pie chart of the distribution of the electrodes in each position.

As shown in Figure 3, at RAO 30°, the red dots represent the two-dimensional distribution of the tips of the LBBAP electrodes in 50 patients. Among these, 28 pacing electrodes were in the PM position, 14 in the M position, 5 in the PI position, and 3 in the MI position. All pacing electrodes were located in the PM, M, PI and MI positions or in the junction area. Overall, 84% of the electrodes were located in the PM and M positions, and the pacing electrodes were densely distributed in the PM position.
