Acute valve malfunction with thrombosed bioprosthetic valve after surgical aortic valve replacement

May 14, 2023

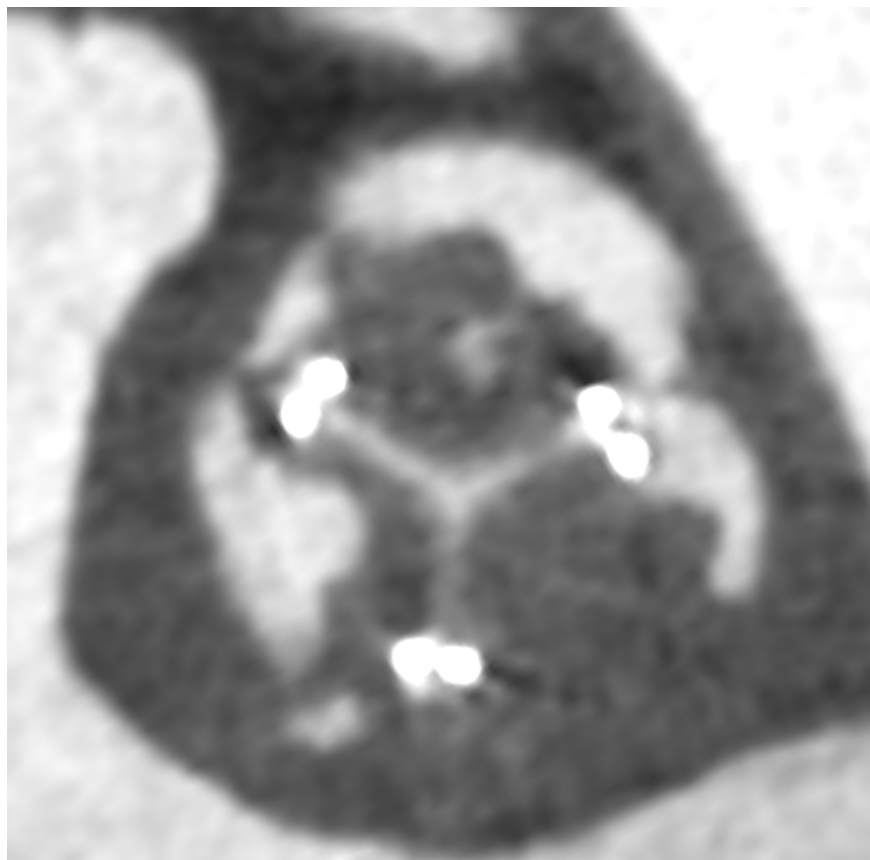
Figure1: Computed tomography(CT) shows thrombi in all leaflets

A 74-year-old man with chest pain was diagnosed with Stanford A acute aortic dissection and severe aortic regurgitation. Aortic valve replacement with a 21mm INSPIRIS (Edwards Lifesciences, Irvine, CA, USA) and ascending aortic replacement with 26mm J Graft (Japan Lifeline, Tokyo) was performed. Anticoagulation therapy using heparin and warfarin was started immediately. Postoperative Computed tomography(CT) revealed thrombus formation to all leaflets of the implanted valve(Figure1) and echocardiography revealed restricted leaflet motion, so surgical thrombectomy was performed. Abundant fresh thrombi adhered to all leaflets of the bioprosthetic valve, and those thrombi were carefully removed (Figure2). No damage or

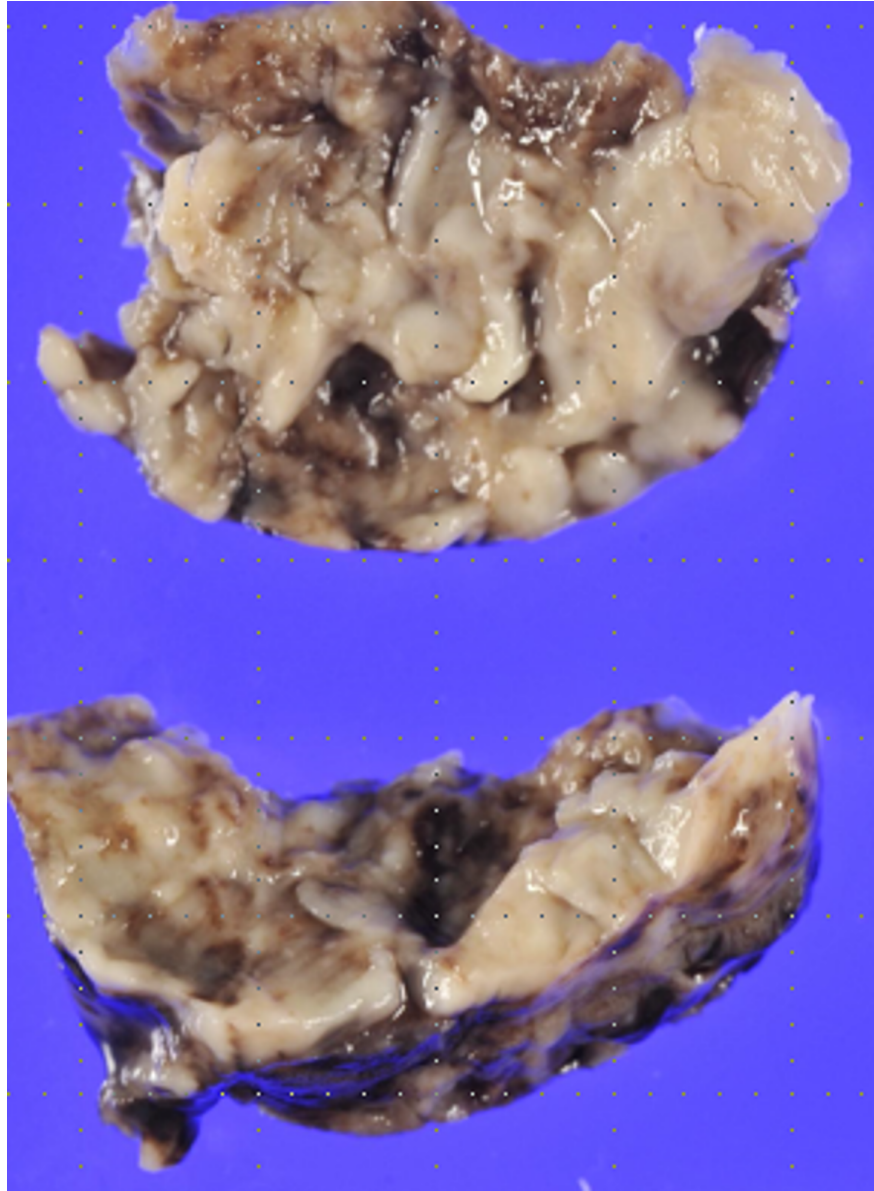
Figure2: All thrombi were removed completely

macroscopic degeneration on the leaflets were seen, so the implanted valve was preserved. We initiated argatroban for 1 week, followed by aspirin and warfarin and postoperative CT showed no sign of thrombus. (Figure 3).

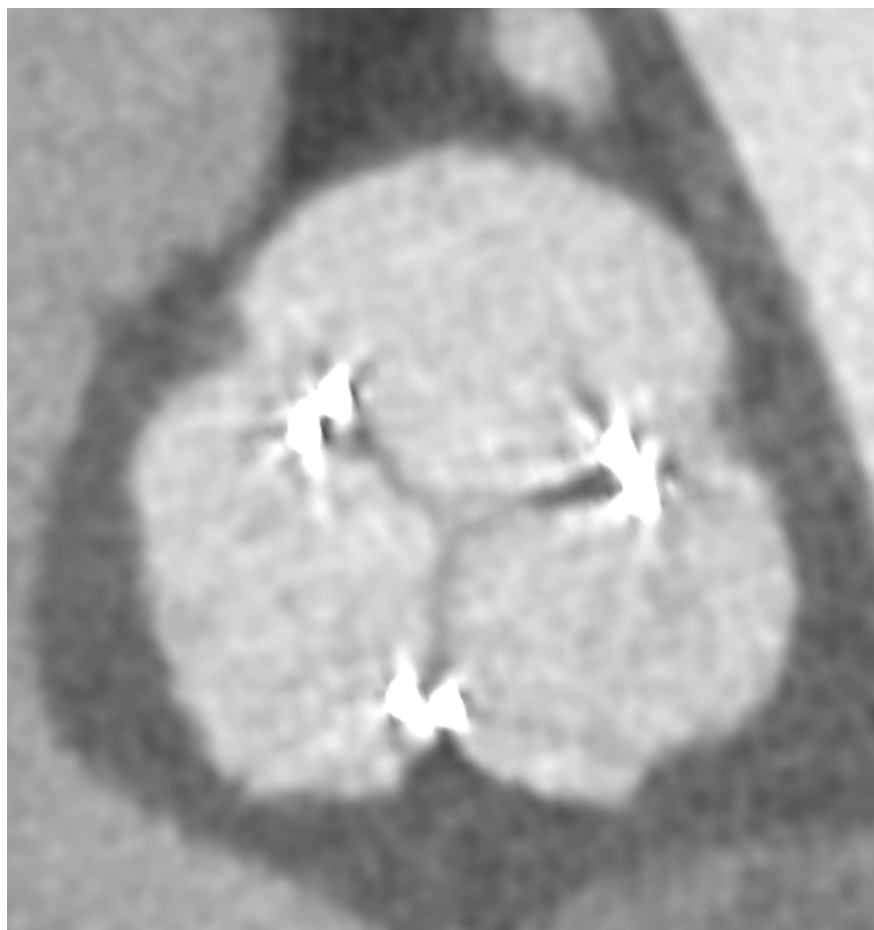
Figure3: Postoperative CT shows no thrombus in bioprosthetic aortic valve
