# Open heart mitral valve replacement using the Edwards-Sapien 3 for severe mitral annular calcification prevents left ventricular outflow tract obstruction

## Abstract

We can safely treat mitral valve disease with mitral annular calcification using Sapien 3 valve through the incision of the right side of the left atrium under direct visualization preventing atrio-ventricular disruption and left ventricular outflow tract obstruction.

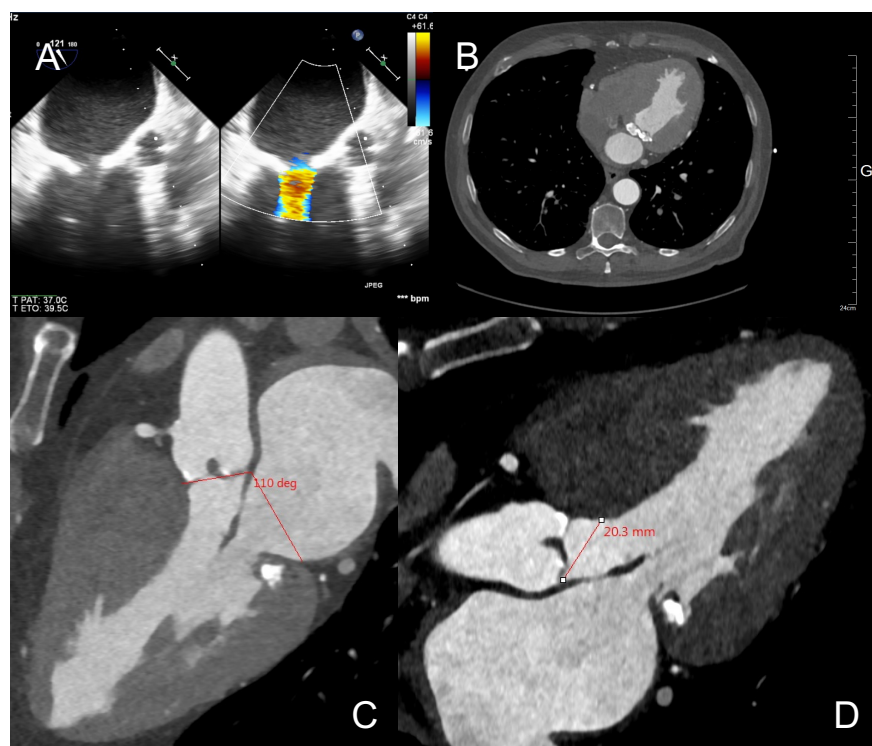
FIGURE 1 A, Pre-operative transesophageal echocardiography showed calcified MV and MAC with turbulent flow at the MV in systole. B, Pre-operative CT showed MAC. C, Aortomitral angle was 110. D, Pre-operative LVOT. The measurement is parallel to the TAVI prosthesis.

Echocardiography showed severe MS with a mean pressure gradient (PG) of 12 mmHg and a mitral valve (MV) area of 0.99 cm<sup>2</sup> (Figure. 1A). The left ventricle (LV) was hypertrophic and the LV ejection fraction was 70%. AS was also severe and the aortic valve (AV) area was 0.74 cm<sup>2</sup>. MAC was severe as shown on computed tomography (CT) (Figure. 1B). The pre-operative aortomitral angle was 110 (Figure. 1C), so the risk of LVOT obstruction was high<sup>3</sup>. The width of the pre-operative LVOT in the direction of placing the TAVI prosthesis was 20.3 mm (Figure. 1D). The extra space after performing TMVI becomes neo-LVOT. We can estimate post-procedural LVOT obstruction taking measurement of neo-LVOT at the baseline CT scan.

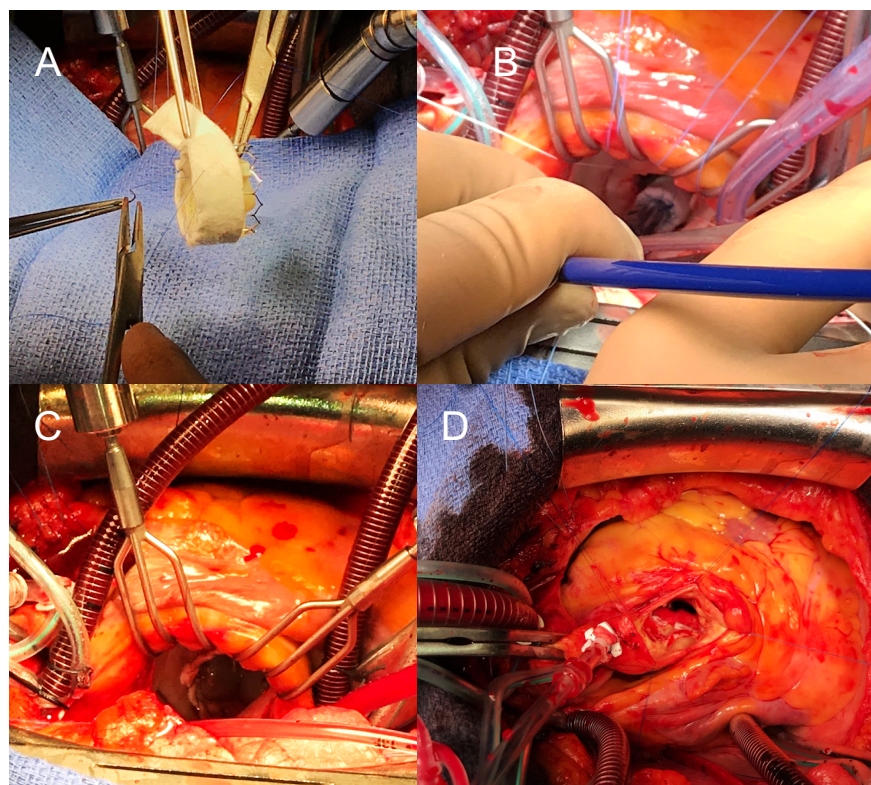
FIGURE 2 A, Felt strip sewn to the Sapien to cover the polyethylene terephthalate portion. B, Valve implantation. C, After the valve implantation, anchor sutures were sewn to the felt strip and tied thereafter. D, Visualization via the aortotomy enabled us to view the Sapien at the mitral position and there was no obstruction at the LVOT.

After a median sternotomy on cardiopulmonary bypass with cardioplegic cardiac arrest, the calcified AV was resected through an aortotomy. The aortic annulus was small and a 19-mm AVALUS valve sizer (Medtronic, Minneapolis, MN, USA) was suitable. The left atrium was opened parallel to the interatrial groove. We resected the A2 valve to prevent anterior MV protrusion in the LVOT and secondary LVOT obstruction. We sewed anchor sutures around the mitral annulus (2-0 coated braided polyester sutures with pledgets) in

places where needles exhibited no resistance around or across calcifications. These sutures were used to fix the final position of the TAVI prosthesis once inflated. We measured the mitral annulus using valve sizers of mitral mechanical valve and we chose a valve that was exactly the same size as the annulus. As previously described<sup>2</sup>, after washing a 26-mm Sapien-Edwards AV (Edwards Lifesciences, Inc., Irvine, CA, USA), felt strip sewn to the Sapien to cover the polyethylene terephthalate portion (Figure. 2A). The prosthesis was mounted upside down on the short delivery catheter. A Safari XS (Boston Scientific, Natick, MA, USA) was passed into the catheter to avoid injury of the LV. The balloon was inflated, the valve was deployed under direct visualization (Figure. 2B). During that step, it was necessary to assess the position of the A1 and A2 parts of the mitral annulus on the felt strip to reduce the amount of covered stent into the LVOT. Usually the width of the felt strip is approximately 1 cm and a residual 5-6 mm width in the atrial side is likely to avoid LVOT obstruction. Then, the valve was fixed in its position by passing the previous anchor sutures across the bottom of the Sapien and tied with the Corknot device (LSI Solutions, Victor, NY, USA) to prevent valve migration. These sutures, in our opinion, also reduced paravalvular leaks (PVL) (Figure. 2C). After we closed the left atrium, we replaced the AV with a 19-mm AVALUS (Medtronic). Visualization through the aortic annulus confirmed that only a limited part of the felt strip was positioned into the LVOT, thus obstruction of the LVOT was not likely to occur (Figure. 2D). After we closed the aorta, the cross-clamp was removed after 96 min. While weaning from cardiopulmonary bypass, we temporarily stopped the bypass flow and checked the PG between the LV (109/12 mmHg) (needle through the ventricular wall) and the ascending aorta (94/56 mmHg). Because the direct pressure is higher than the pressure measured by echocardiography, and the mean gradient measured by echocardiography after AV replacement using AVALUS is between 10 and 15 mmHg, this maximum PG was acceptable<sup>4</sup>. Transthoracic echocardiography 3 month post-operatively showed no PVL at the mitral prosthesis and confirmed no significant LVOT obstruction.
